5600 148th Lane Northwest, Ramsey, MN February 21, 2020

Report No. 1271

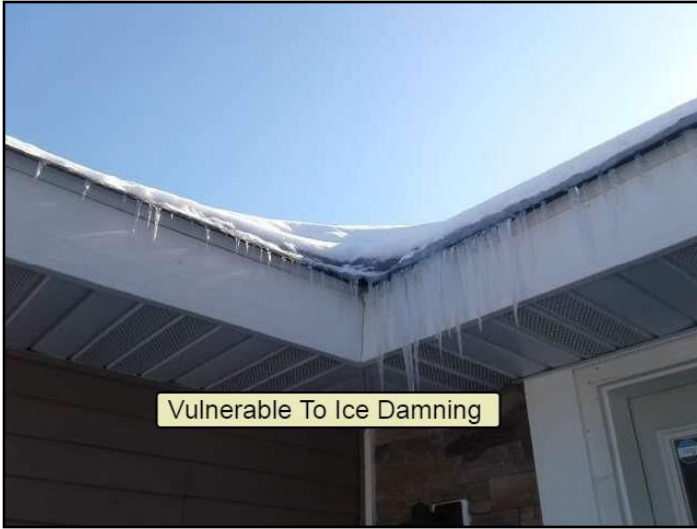
The area at the back of the garage is vulnerable to ice dam's. Be sure to keep snow removed from the roof line in this area.

2. Vulnerable to ice damming

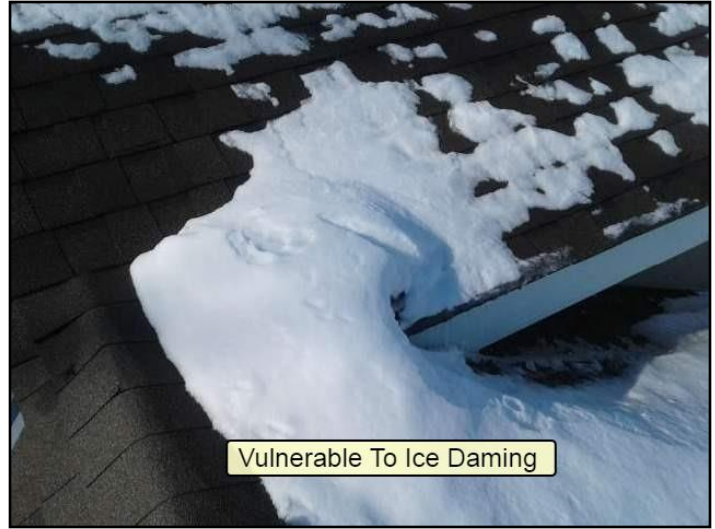
3. Vulnerable to ice damming

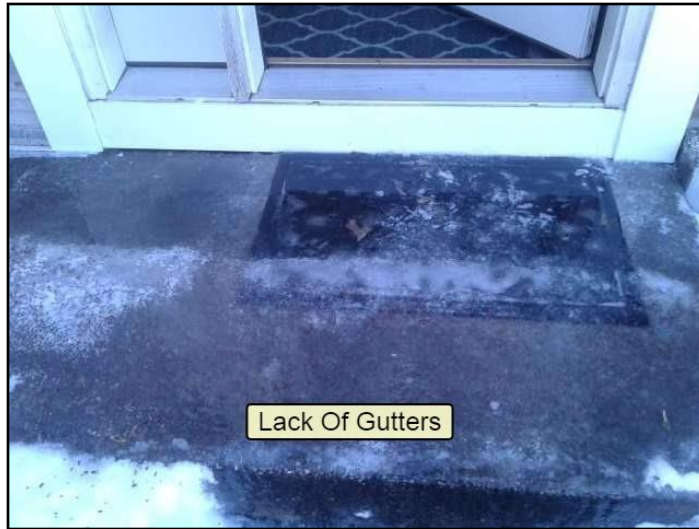
Installation of gutters and downspouts is always recommended to keep rain water away from the building foundation.

4. Missing

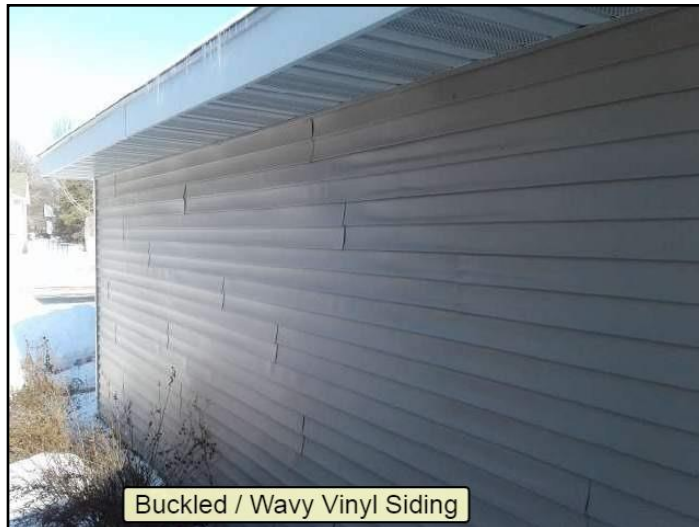
The vinyl siding on the west side of the garage has buckled.

5. Buckled or wavy

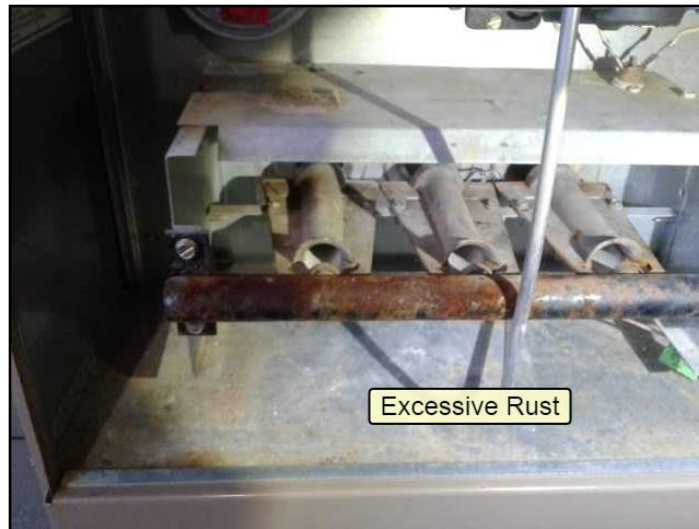
There is rust inside the furnace cabinet. It appears to be coming from an overflowing condensate pan. Continued monitoring is recommended and making sure the condensate drain line is clear and free flowing.

12. Rust

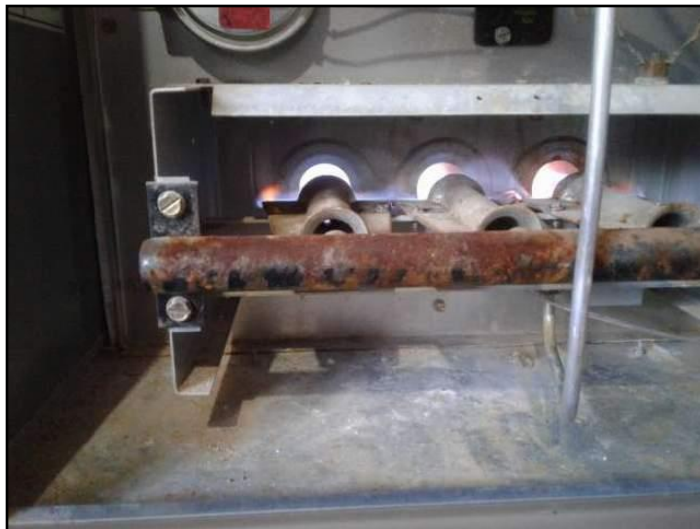
The furnace is showing some poor flame color and distortion. It is recommended that the furnace be checked by a qualified HVAC technician. Make sure to have the furnace serviced annually.

**13.** *Poor flame color or pattern*

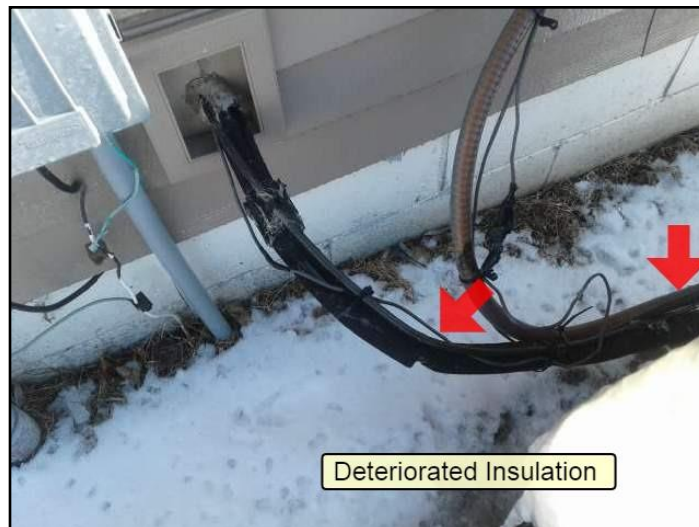
The insulation for the refrigeration line to the Air Conditioner has deteriorated and should be replaced

15. Insulation - missing

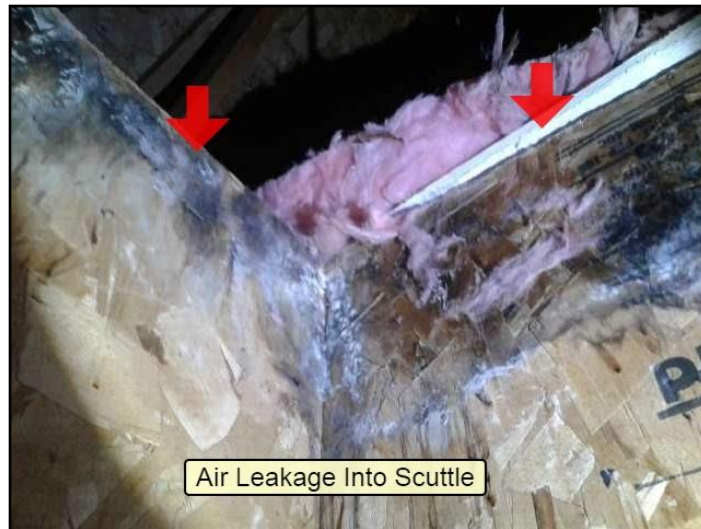
There is air leakage into the scuttle area of the attic. This should be sealed to prevent air leakage into the attic space.

17. Not weatherstripped

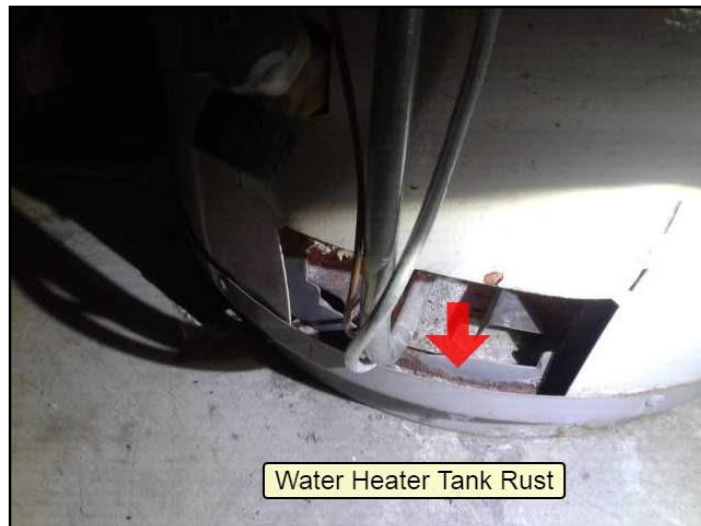
The bottom of the water heater is showing starting to rust. Signs that it might be coming to the end of its effective life.

24. Rust

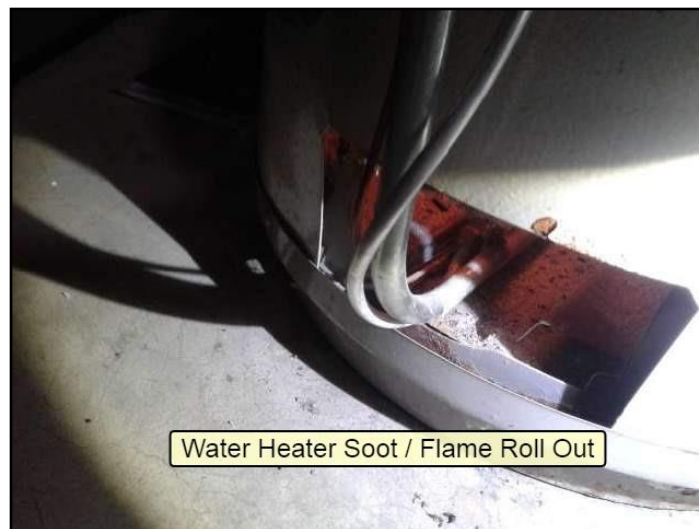
The water heater has a build up of soot and the burner flame rolls out when igniting. Signs that the water heaters effective life might be coming to an end. Replacement should be anticipated.

25. Dirt or soot

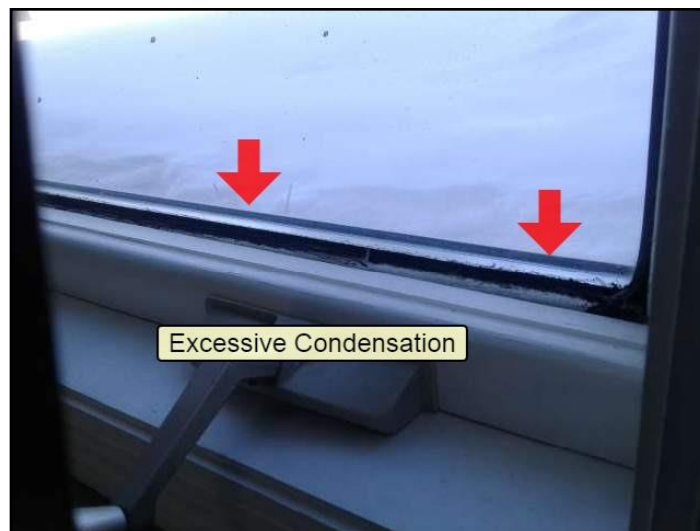
With the lower level bathroom having no exhaust fan, there is excessive condensation on the window causing rot to the frame.

26. Excess condensation

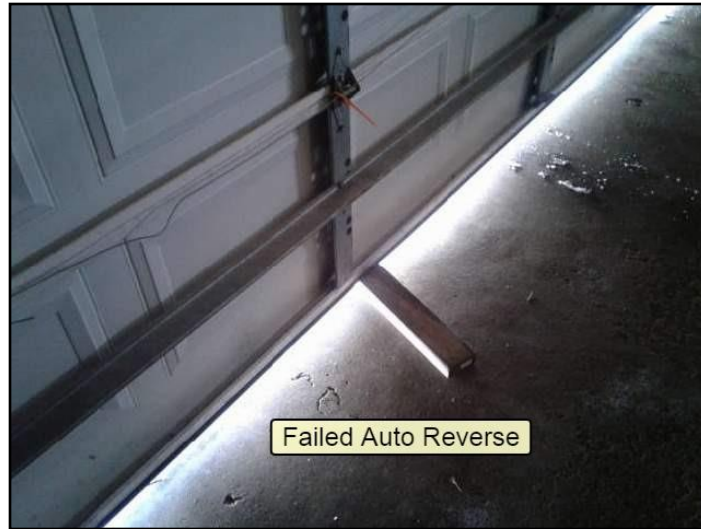
27. Fails to auto reverse

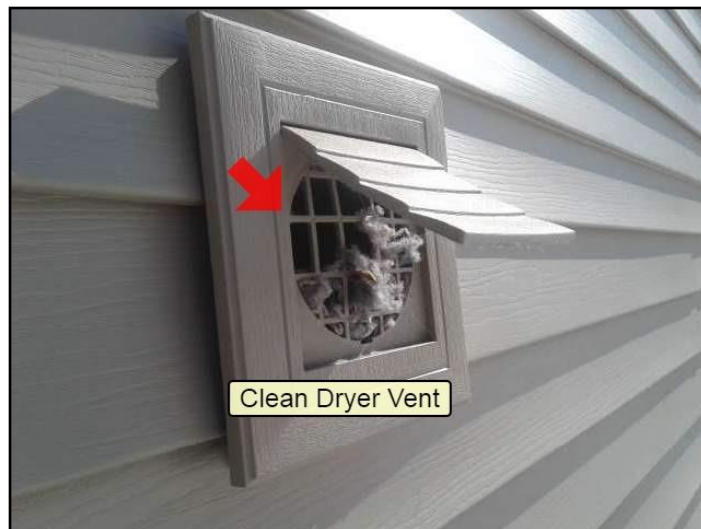
28. Make sure to clean the dryer vent twice...
