5600 148th Lane Northwest, Ramsey, MN February 21, 2020

Report No. 1271

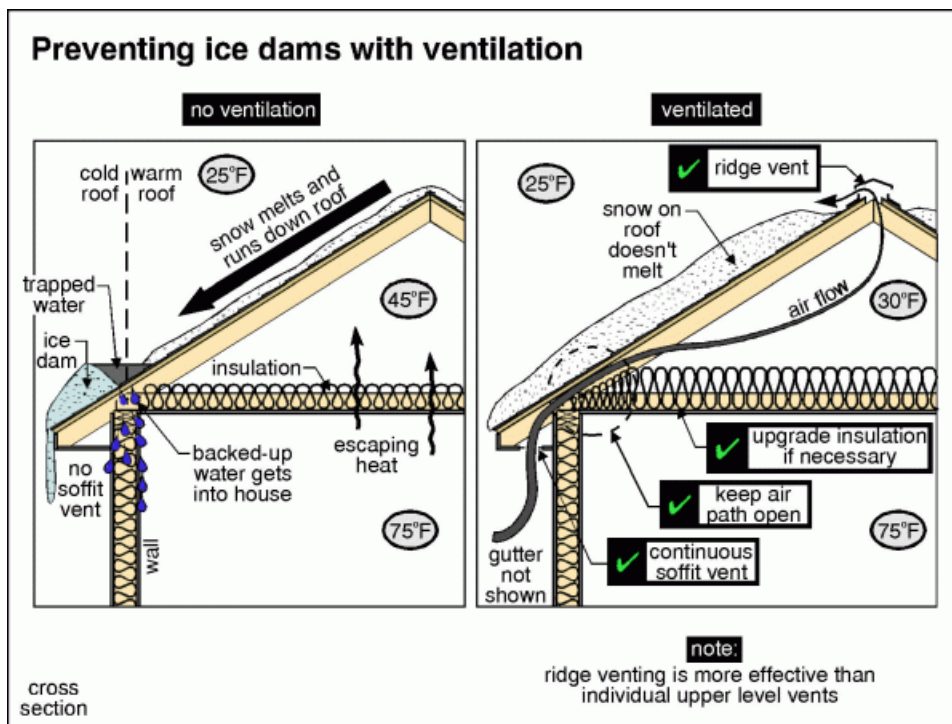
The area at the back of the garage is vulnerable to ice dam's. Be sure to keep snow removed from the roof line in this area.

#### 1. Condition: • Vulnerable to ice damming

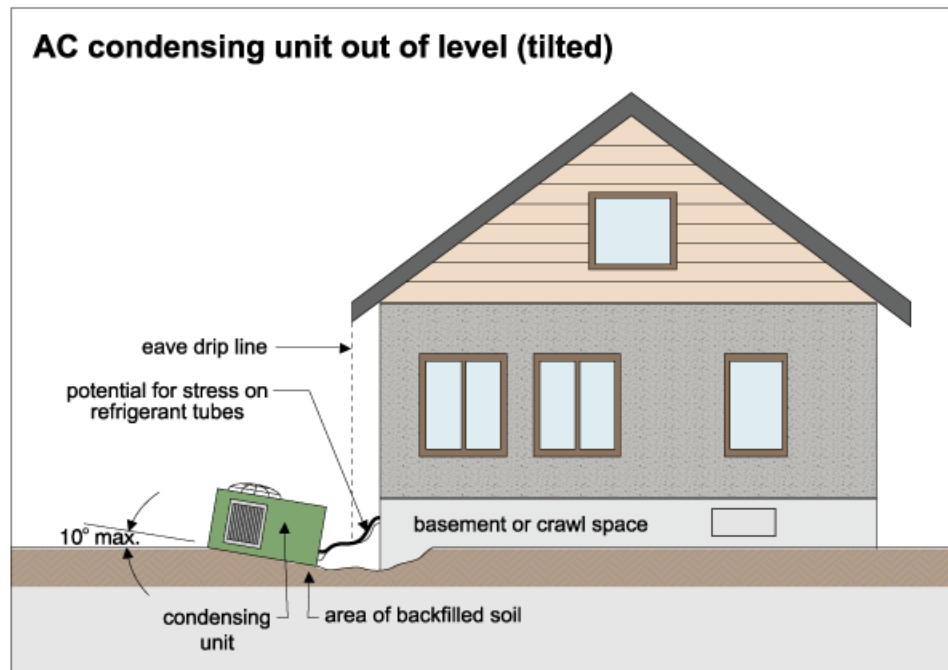
**7. Condition:** • [Out of level](#)

The air conditioner should be brought back to level to provide optimum efficiency.

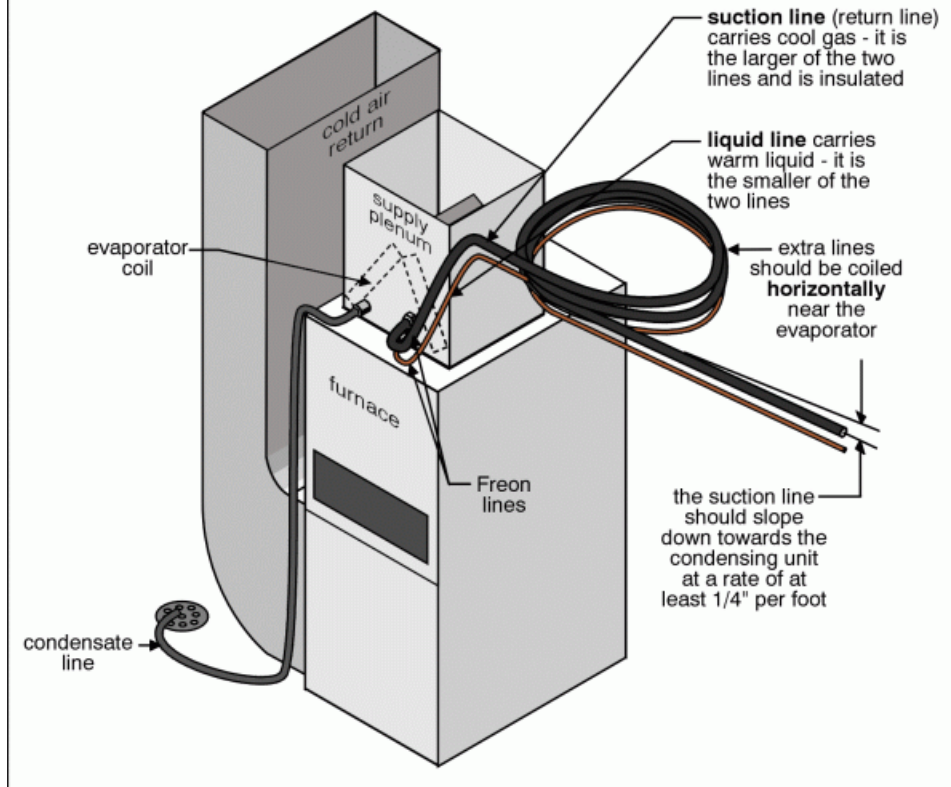
15. Insulation - missing

### 8. Condition: • [Insulation - missing](#)

The insulation for the refrigeration line to the Air Conditioner has deteriorated and should be replaced

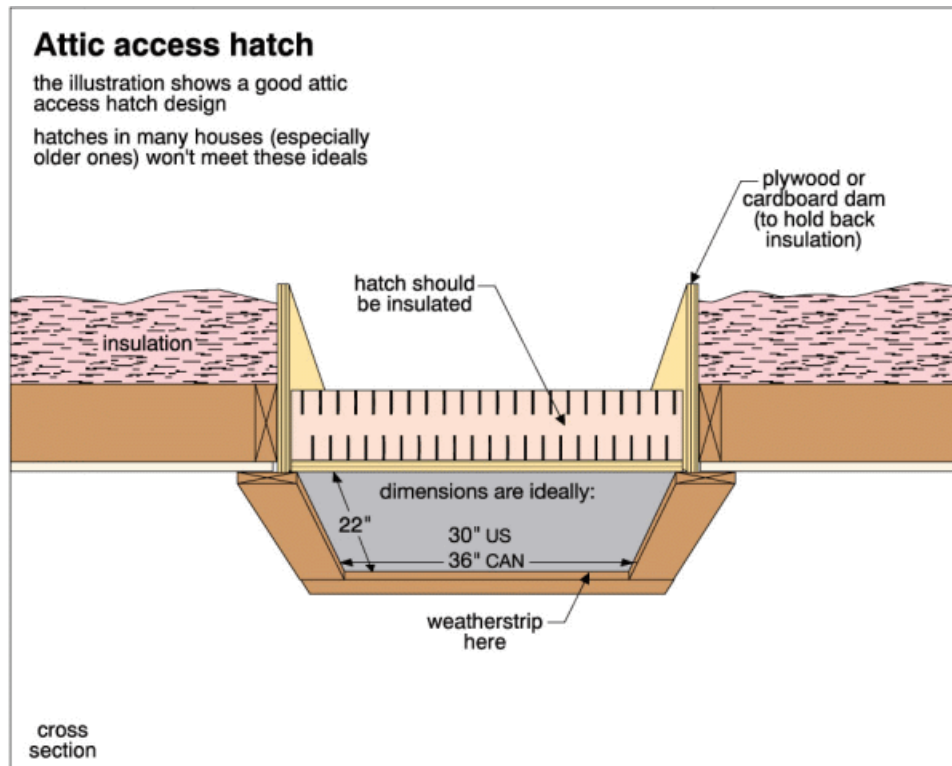
**9. Condition:** • [Not weatherstripped](#)

There is air leakage into the scuttle area of the attic. This should be sealed to prevent air leakage into the attic space.

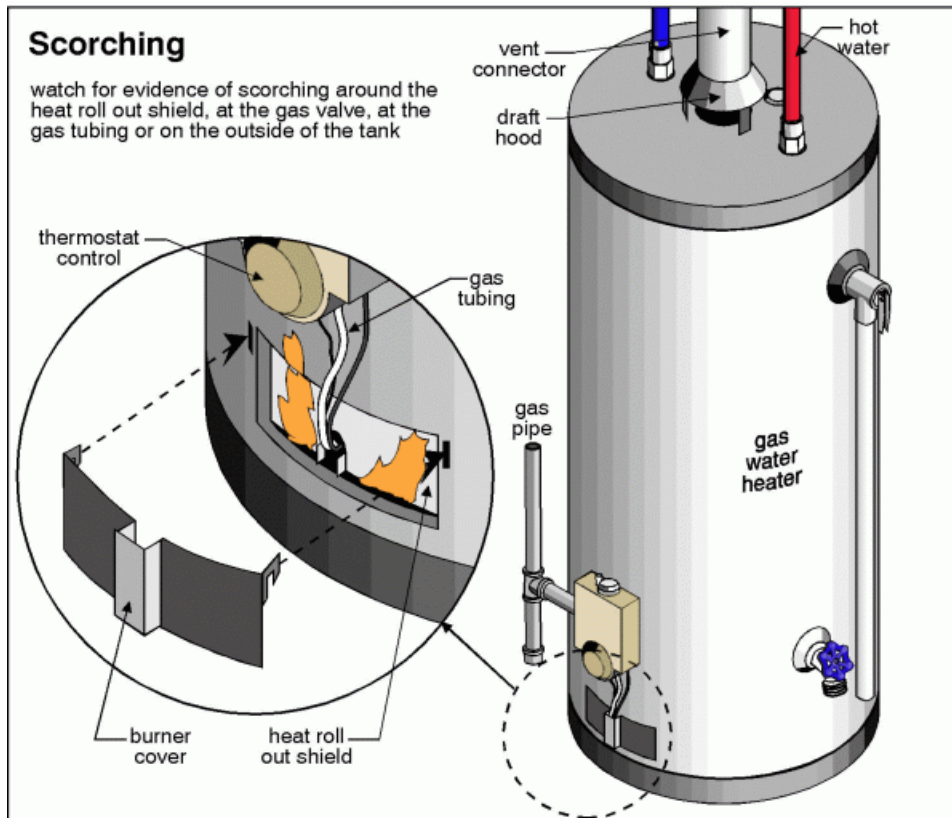
25. Dirt or soot

**11. Condition:** • [Dirt or soot](#)

The water heater has a build up of soot and the burner flame rolls out when igniting. Signs that the water heaters effective life might be coming to an end. Replacement should be anticipated.

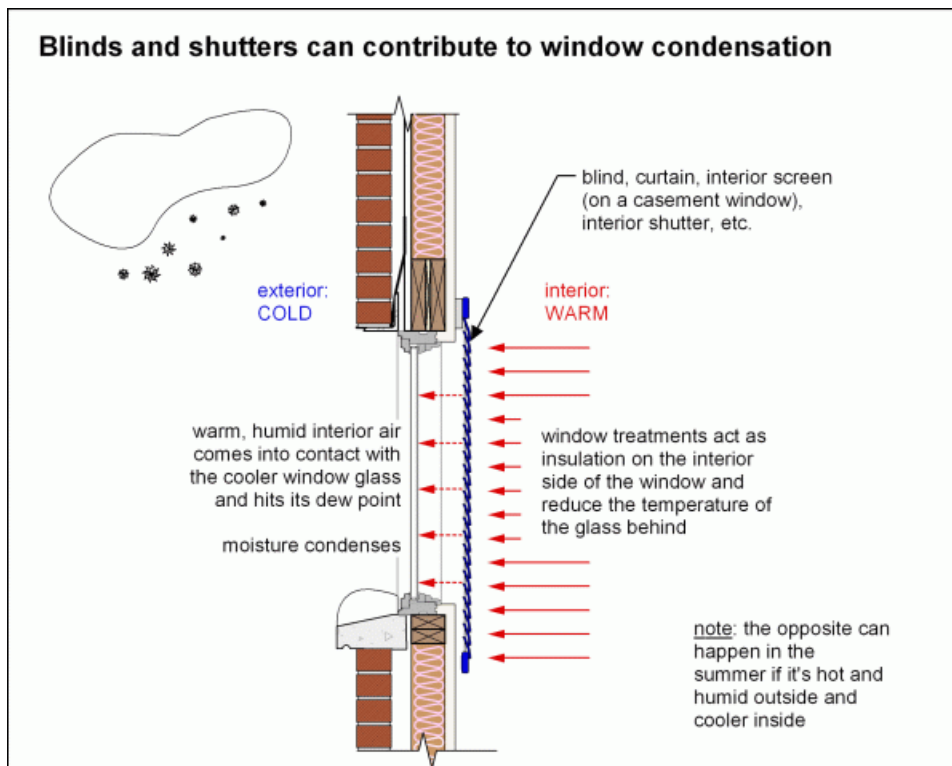
26. Excess condensation

**12. Condition:** • [Excess condensation](#)

With the lower level bathroom having no exhaust fan, there is excessive condensation on the window causing rot to the frame.

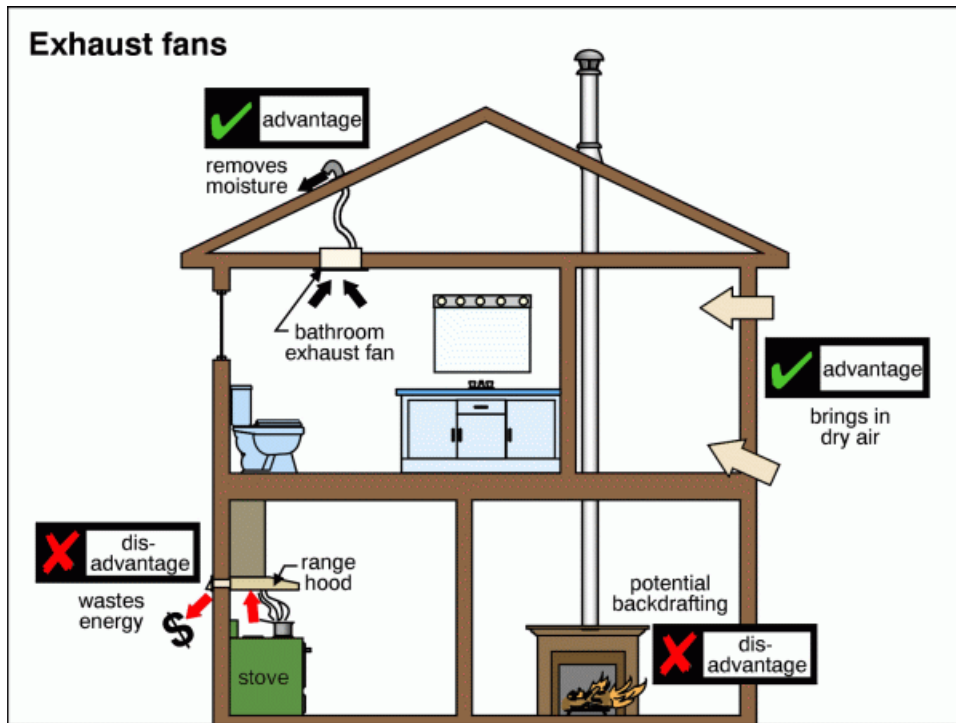
### 13. Condition: • [Missing](#)

The lower level bathroom has no exhaust fan.
